Manhole Inspection Summary

Manhole # S33UU_022MH

Location Address: **2700 MORTON AVE**

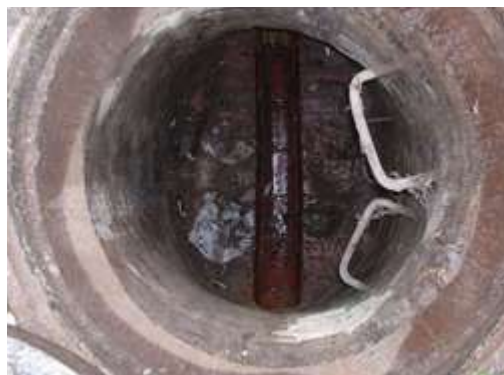
Top View

Evidence of surcharge - Bench debris.
Channel debris.

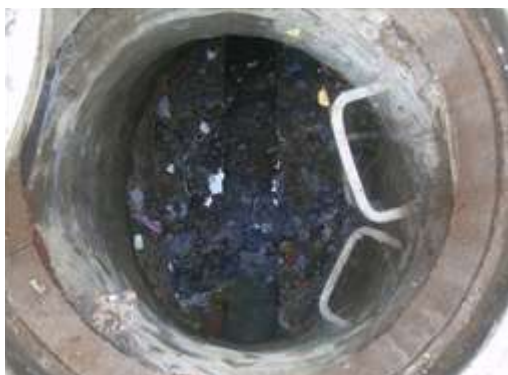
Top View

Evidence of surcharge - Bench debris.
Channel debris.

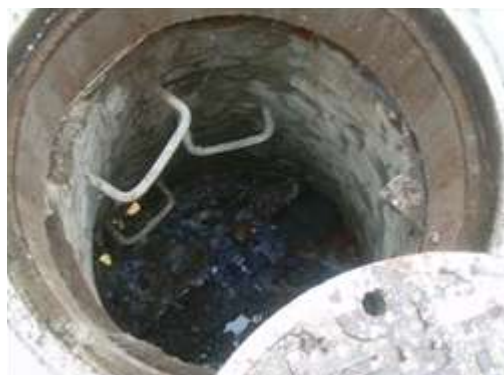
Defect

Frame leaks. Cracked frame. Adjustment
deterioration, loose brick and infiltration.
Corbel and Barrel infiltration - other side.

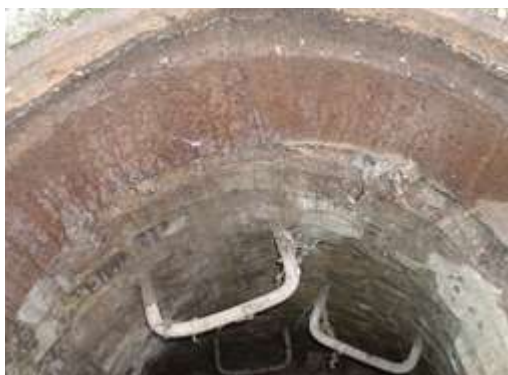
Defect

Frame leaks. Adjustment, Corbel and
Barrel infiltration.

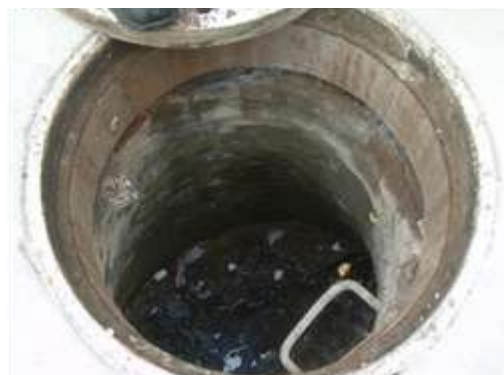
Defect

Frame leaks. Cracked frame. Adjustment
deterioration, loose brick and infiltration.
Corbel and Barrel infiltration.

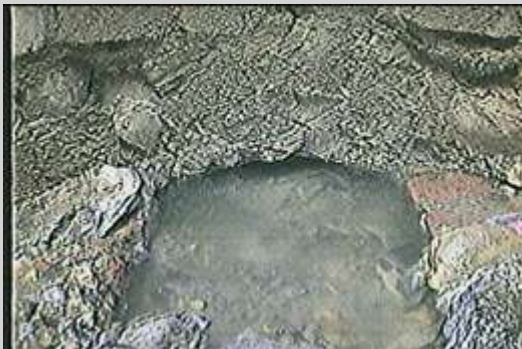
8 in. Circular Gravity Sewer Pipe In @ 6 O'Clock

Deposits: ☐ None ☒ **Mud** ☐ Sludge ☒ **Debris** ☐ Grease

Silt Depth: **4** (in.) Deposits Extent: **Heavy**
